Manhole Inspection Summary

Manhole # S29A__009MH

Insp Date: **12/11/07 10:52 AM**

Location Address: **1009 ARGYLE ST**

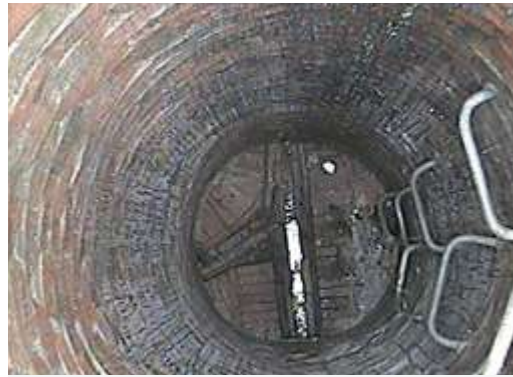
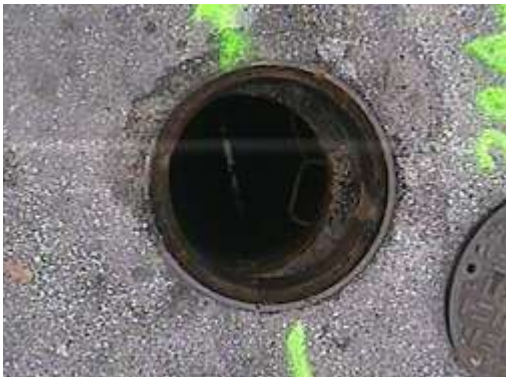
Top View

Condition: **Cracked**

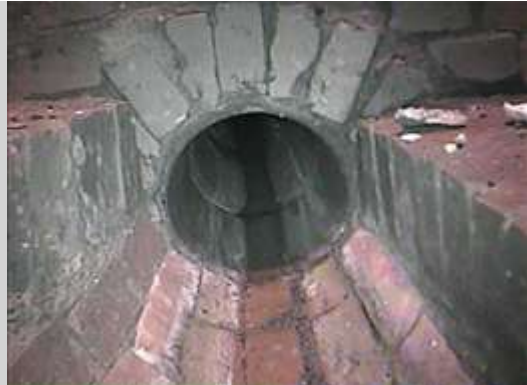
12 O'Clock Outflow

8 in. Circular Gravity Sewer
Pipe Out @ 12 O'Clock

Pipe Height: (in.) Direct
Pipe Material: **Clay** ☐ Pipe Lined
Invert Depth: **12.70** (ft.) Flow Characteristics: **Slow**
Deposits: ☒ None ☐ Mud ☐ Sludge ☐ Debris ☐ Grease
Silt Depth: (in.) Deposits Extent:
Infiltration: **None** Pipe Seal Cond: **Sound**

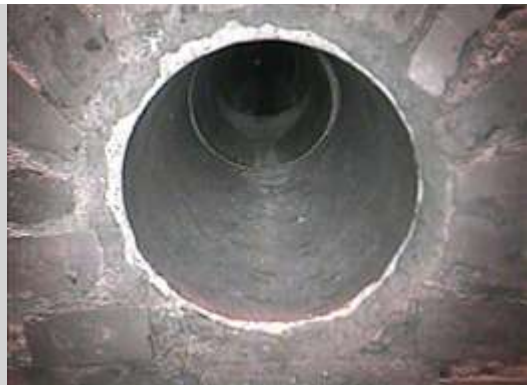
6 O'Clock Inflow

8 in. Circular Gravity Sewer
Pipe In @ 6 O'Clock

Pipe Height: (in.) Direct
Pipe Material: **Clay** ☐ Pipe Lined
Invert Depth: **9.92** (ft.) Flow Characteristics: **Slow**
Deposits: ☒ None ☐ Mud ☐ Sludge ☐ Debris ☐ Grease
Silt Depth: (in.) Deposits Extent:
Infiltration: **None** Pipe Seal Cond: **Sound**

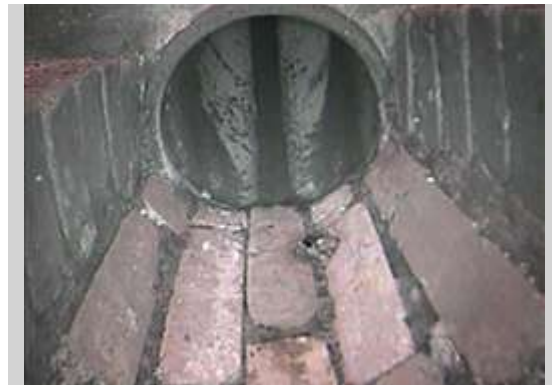
Drop In @ 6 O'Clock

Drop: **Outside Direct**
Angled: Reading: (ft.)
Inv Depth: **12.65** (ft.)
Drop Condition: **Open**

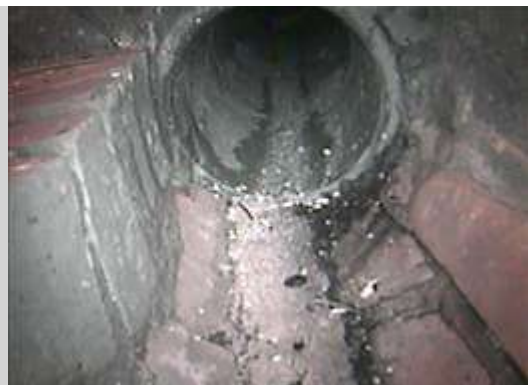
9 O'Clock Inflow

6 in. Circular Gravity Sewer

Pipe In @ 9 O'Clock

Invert Depth: **12.21** (ft.) Flow Characteristics: **None**

Infiltration: **None**

Pipe Seal Cond: **Sound**
